# VILLAGE OF NILES

## Village of Niles, Illinois Stormwater Commission Report

**September 22, 2009**

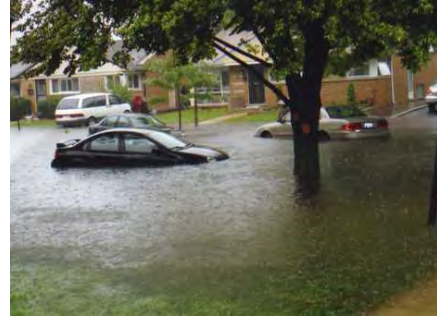
**Photo 4-1: Street Flooding**

**4.2.1. Street/alley flooding** – There are a number of streets that flood during significant rain falls (See Appendix M). One contributor to flooding may be clogged or obstructed sewer inlets, restrictors, and/or sewers. Some sewers are simply too small or may require a separated sewer system. Another reason for street flooding is that some roads are meant to serve as a secondary conveyor of stormwater during extreme events so that the road floods instead of the buildings along the street. This is done by installing an inlet restrictor valve.

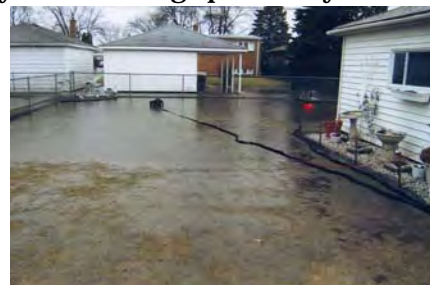
**Photo 4-3: Rear Yard Flooding**

**4.2.2. Yard flooding** – Beyond in-home, yard flooding (primarily rear yard) is by far the most aggravating stormwater issue for many homeowners in the Village of Niles (See Appendix M).

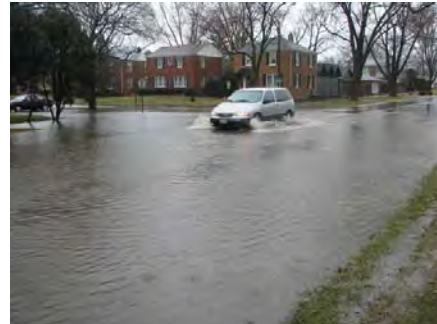
**4.2.3. Stormwater runoff** – Stormwater runoff from 3<sup>rd</sup> party properties is a significant issue in the Village of Niles. This runoff is coming from public and private parks, parking lots, cemeteries, and adjacent municipalities. Over the past year, the Commission has been working with several 3<sup>rd</sup> parties to work on solutions.

**Photo 4-4: Stormwater Runoff & Vehicle Wake**

The issues caused by this stormwater runoff that is not detained or retained:

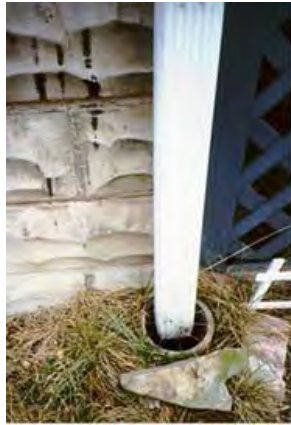
**Figure 4-3:  
Downspout Inflow**

**Example of Inflow:**  
A downspout connected directly to the combined sewer system.

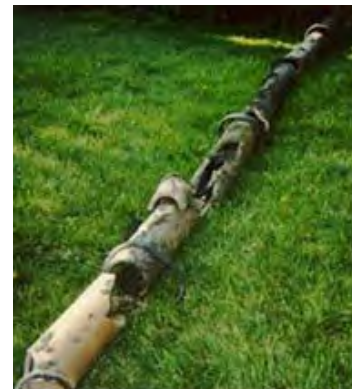
**Figure 4-4: Home  
Lateral Infiltration**

Infiltration is from ground water or excess stormwater that enters the combined sewer through open joints, cracks, breaks in the pipes and/or damaged household laterals. The average household lateral is designed to last about 20-50 years, depending on material, settlement, or root intrusion. In many cases, however, they go too long without inspection or repair.

**Example of Infiltration:**  
A deteriorated house lateral that allowed water to seep into the combined sewer

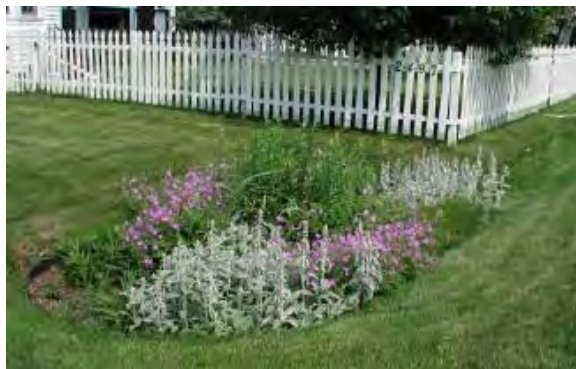
**Figure 4-5: Residential Rain Garden**

Rain gardens utilizing native plantings – Glenview and Palatine have implemented a rain garden program to reduce the amount of stormwater entering sewer systems during peak flow periods.

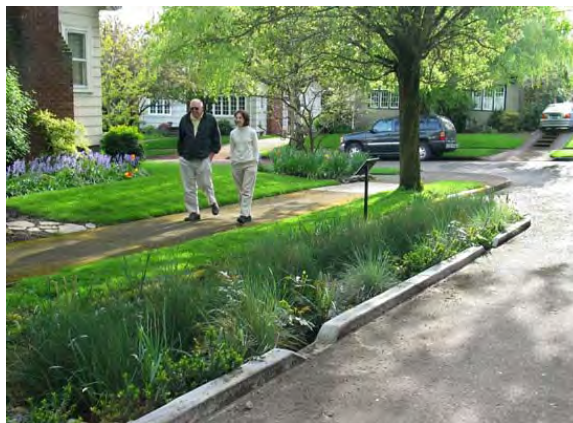
**Figure 4-7: Residential Street Bioretention/Green Street**

Figure 4-7 demonstrates how bioretention may be utilized on a side street to increase stormwater capacity where new or larger sewers are not an option.

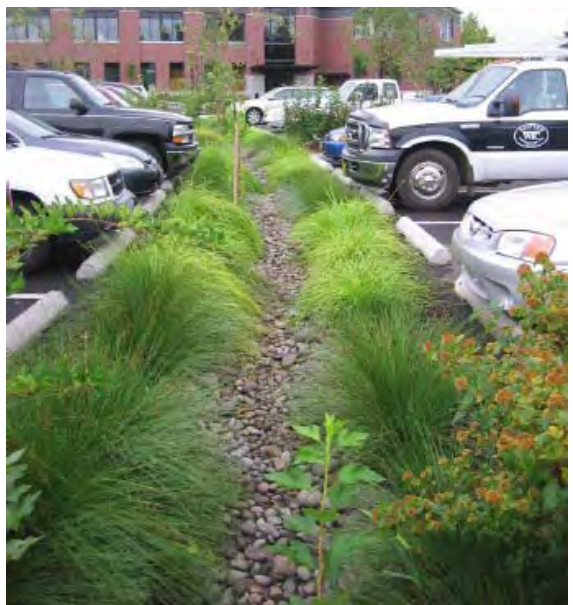
**Figure 4-8: Parking Lot Bioretention Islands**

Figure 4-8 demonstrates how parking lot bioretention islands can replace “raised islands” to increase stormwater capacity and reduce the amount of stormwater that enters a local combined or storm sewer system.
